TP 185E
Issue 2/2011

AVIATION SAFETY LETTER

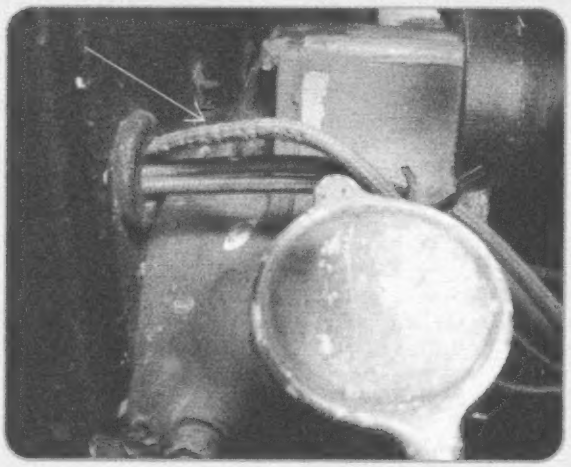
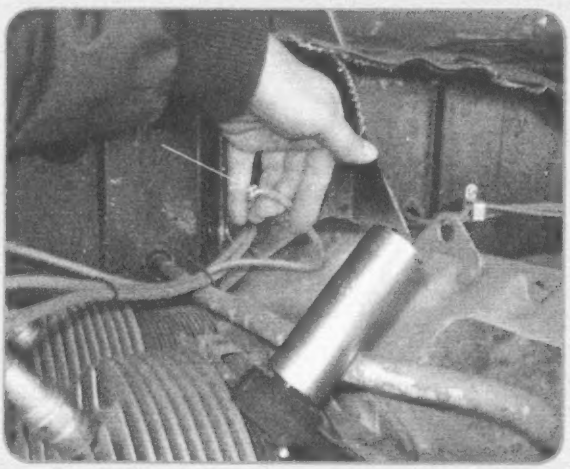
If not for ice, watch for mice...

Mr. Paul Harrington of Cottam, Ontario, thought this would be of interest to ASL readers. Just after maintenance on a Cessna 172, he pushed the aircraft out to run it up, and he suddenly had a large drop on the right magneto. He decided to check the spark plugs and ignition wires, so he pushed the aircraft back in the hangar, took the cowls off, and found number 5 magneto wire with the top chewed in half, and other wires with teeth marks. In 36 years of working on aircraft, Mr. Harrington said this was the first time he had ever seen this happening. So, he wanted to share this with pilots and, aircraft maintenance engineers (AME): if you get a magneto drop, you may want to double-check the condition of the ignition wires! He replaced the right magneto harness; for some reason, the mice didn't touch the left one. Be careful out there!

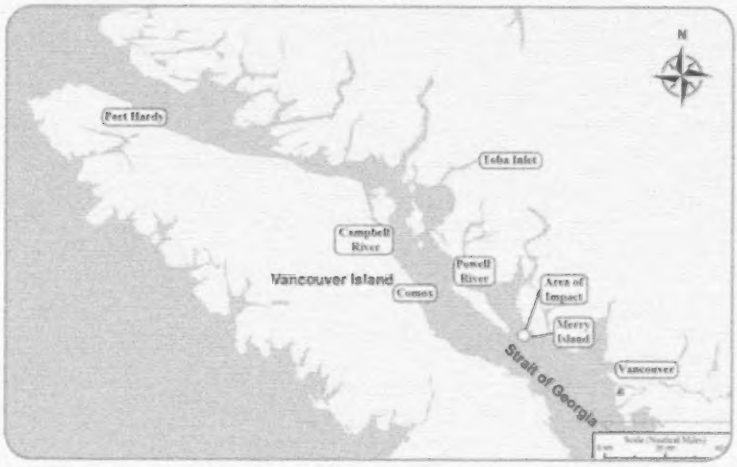
Area map with relevant weather information locations available to the pilot

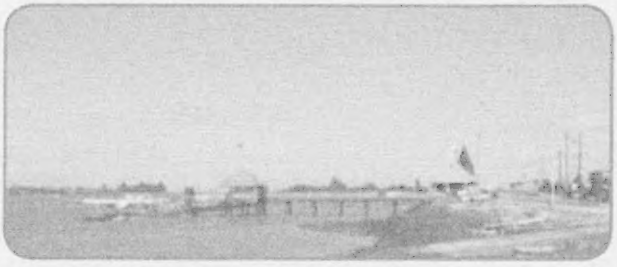
Given the conditions at takeoff and at the accident site, as well as the forecast and reported conditions for the en route section, it is likely that most of the flight was conducted below the required VFR minima. The conditions present on the day of the occurrence would have resulted in a high likelihood that IMC conditions would be encountered. The visibility portrayed in the photograph as the aircraft taxied into the river at Vancouver (see Photo 1) displays conditions below SVFR minima for fixed-wing aircraft.

Photo 1. Aircraft entering river for takeoff (accident flight.) Photo courtesy of Mr. Rich Malone, who captured it with his cell phone.

Photo 2. Same location as Photo 1 taken on clear day

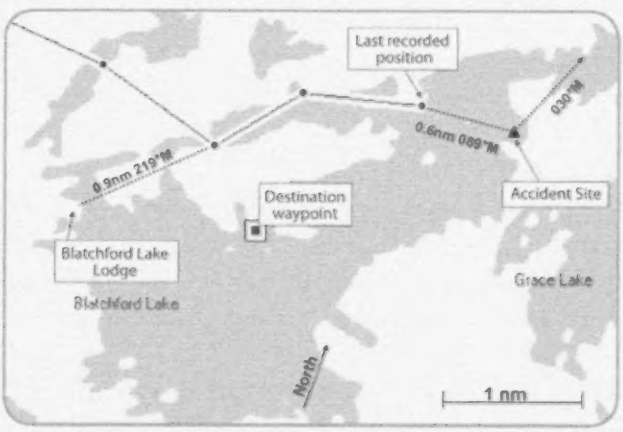
Map of area

Under the operator's Transport Canada exemption for operations below 1 000 ft AGL with less than two miles of flight visibility, the pilot had to be trained in the use of a global positioning system (GPS) receiver. There is no record of his having received the required instruction. The coordinates entered for the lodge were about a mile east of the lodge, and the pilot had turned northeast (away from the lodge) before reaching this waypoint. There is a probability that the pilot abandoned the use of the GPS when he reached the north shore of the lake, and turned left to follow the shore of the lake for navigation, since his visual reference was out his left side window with his windshield obscured by ice. His subsequent flight path continued to track eastward away from the GPS waypoint and away from the lodge, until the aircraft crashed.

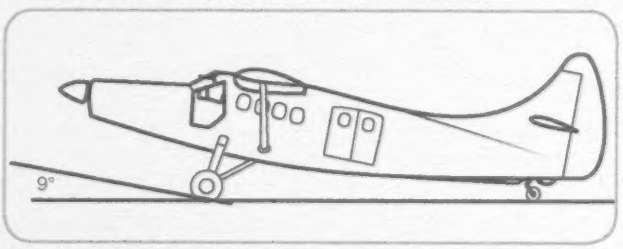
Figure 1: de Havilland DHC-3T Turbo Otter

The aircraft was loaded with a mixture of rough and finished lumber weighing approximately 2 213 lbs. The cargo was composed of six 16-ft rough beams measuring 7 ½ in. by 7 ½ in., a selection of 16-ft rough lumber, and a selection of 10-, 12- and 14-ft finished boards. The lumber was loaded so that all the boards were flush with the front of the cabin. At rest, the aircraft described a 9 degree nose-up attitude, resulting in the cargo being loaded in an "uphill" manner while the aircraft was on the ground (see figure 1). Before the occurrence flight, several loads of lumber had been hauled to the same destination.

The load was secured with a single one-inch cargo strap that was placed over the lumber. The strap was fastened to tie-down points located ahead of the rear cargo doors. The floor of the aircraft was plywood. The maximum aft centre of gravity (CG) limit was determined to be 152.2 in. The CG of the occurrence aircraft was calculated to be 154.8 in. aft of the datum, 2.6 in. behind the rearward limit.

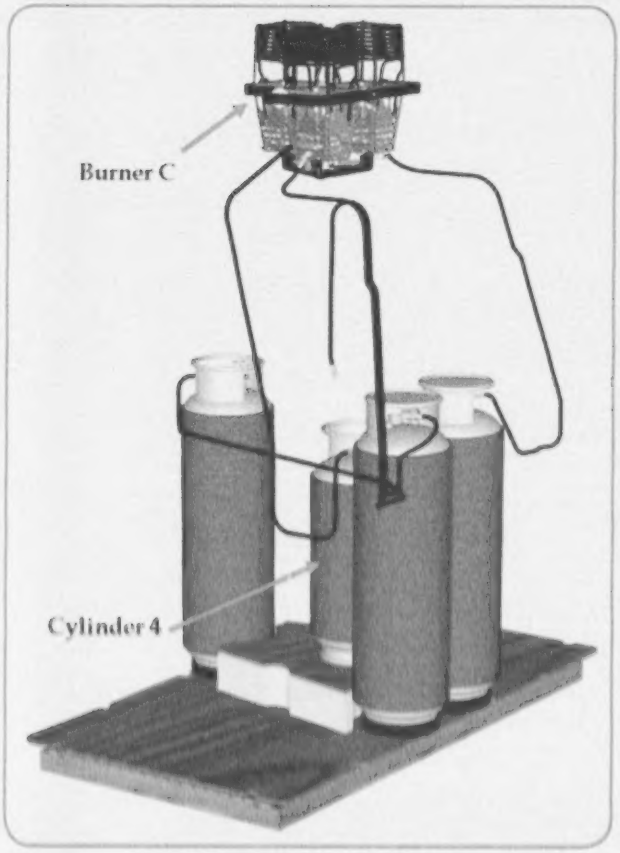
The pilot's practice was to coil the number 4 cylinder fuel line around the cylinder when not in use. That practice, in addition to the practice of connecting and disconnecting the line during every flight, probably led to more stress on the tank valve/fuel line connection. This extra wear and tear likely led to the hose pulling out of its end fitting.

As the number 4 cylinder was the source of the propane fuelling the fire, closing that cylinder's tank valve would have removed the fuel source and likely extinguished the fire. However, considering the ferocity of the fire, this was not practical. An emergency fuel shut-off, such as is generally provided in other aircraft fuel systems, was not fitted.

S77A modified configuration

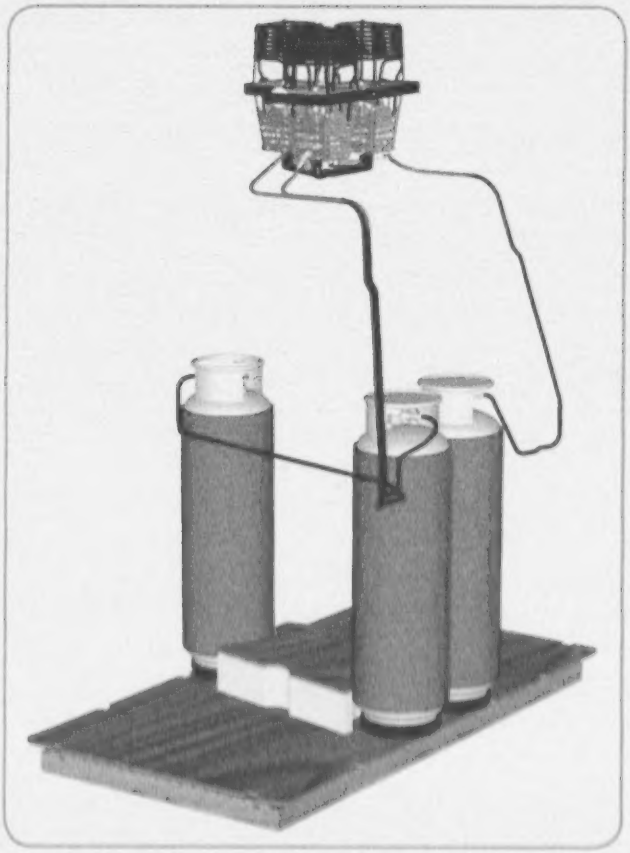
S77A manufacturer's three-burner configuration

The basket was the largest available for this balloon and calculations indicate that the gross weight, with twelve passengers on board, was substantially greater than the maximum allowable gross weight. This increased weight meant more lift was required. More fuel would therefore have to be burned to create the hot air for the added lift. The original configuration of the fuel system did not provide sufficient fuel at the increased weight for the average flight duration. The operator had modified the balloon with a fourth fuel cylinder to provide greater lift and flight time.

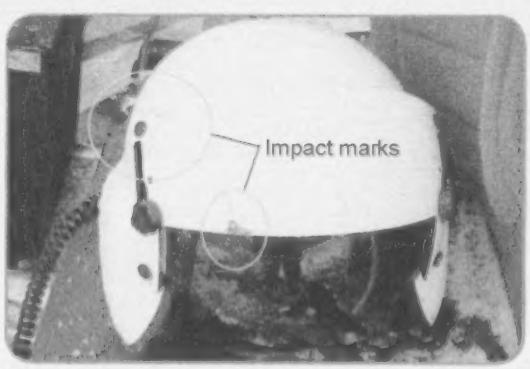
The other pilot was wearing this helmet and did not incur head injuries; scarring on his helmet indicates contact with the helicopter structure during impact sequence.

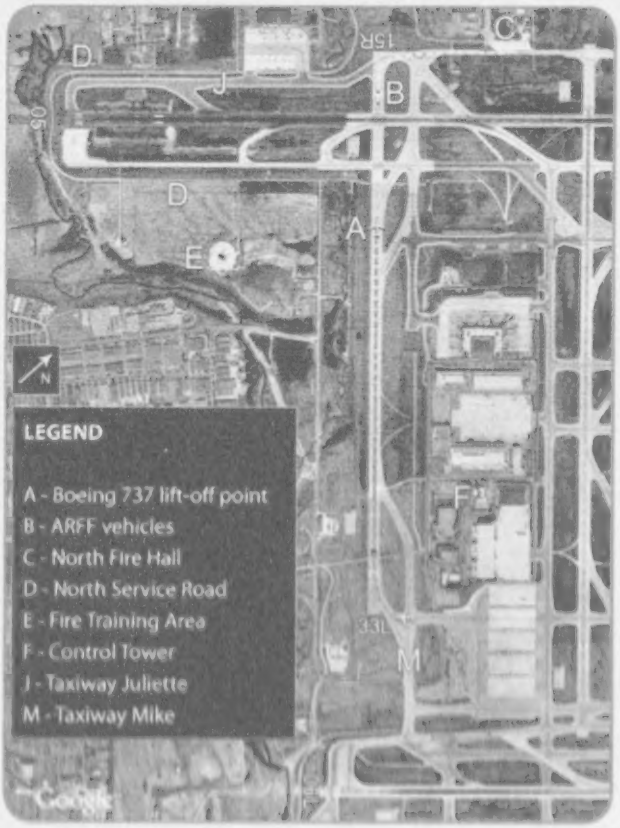
Toronto LPBIA diagram

On July 28, 2008, a Boeing 737-700 was on a scheduled flight from Toronto Lester B. Pearson International Airport (LBPIA), Ont., to Vancouver, B.C. At approximately 1141:50 Eastern Standard Time (EST), the north ground controller, believing that Runway 15 right/33 left (15R/33L) was under the control of the north ground position, cleared three emergency services vehicles to enter Runway 15R/33L en route to the fire training area. At 1142:27, the Boeing 737 was cleared for takeoff from Runway 33L. The aircraft was approximately one-third of the way down the runway when the vehicles entered Runway 15R. The flight became airborne approximately 2500 ft from the vehicles.

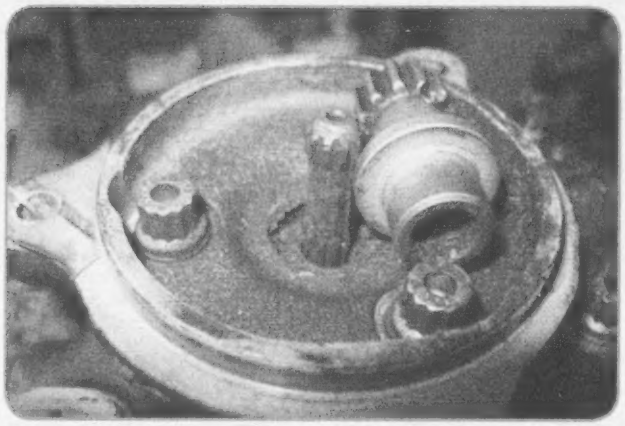
Left engine drive splines and coupling

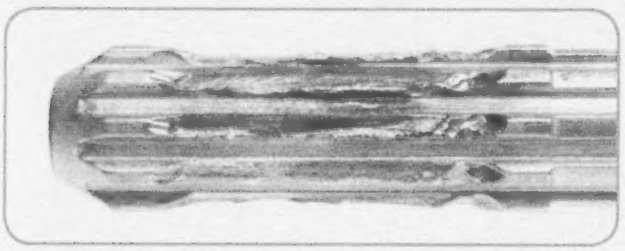
Close-up of external spline wear

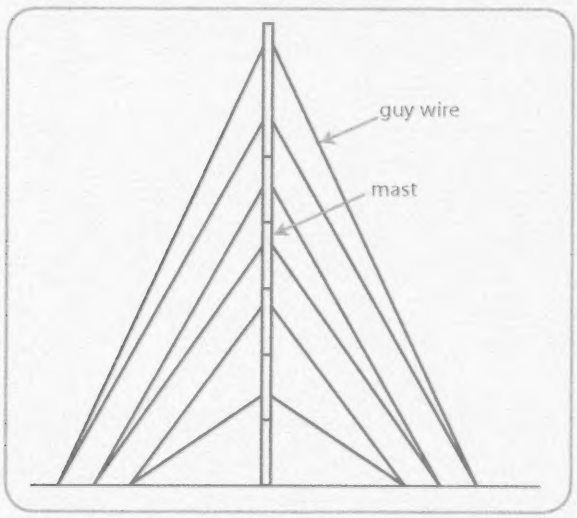
The spraying of crops by means of a specially adapted aircraft is a common activity in rural areas. In order to obtain the most effective application, the aircraft is often flown at heights in the order of three to four meters off the ground. The field, however, may also have a meteorological (MET) tower, which is used to gather data for analysis of the wind resource prior to the construction of a windfarm. These towers have a tubular steel mast that is held in position by sets of guy wires.

MET towers are not normally at a height or location near an aerodrome or recognized flight route, which would require them to be either marked or lit, as stipulated in Transport Canada CAR 621.19. For the same reason, they would not be identified on navigational charts.
